Cross section PR130 was established in 1975 on a curved reach of Powder River that is controlled by bedrock. The stability of the cross section is evidenced by the small amount of lateral erosion of the concave left-side cutbank: only 3.8 m in 38 years. A coal seam outcrops at the level of the river bed on the left bank, which can be seen at low, clear flows (see photos for PR130 in 1975, 1997, and 2012) and appears to dip slightly across the river as it has never been seen along the right bank. This cross section was resurveyed annually during the 4 consecutive years 1977-1980, resurveyed in 1982, resurveyed annually during the 18 consecutive years 1984-2001, and, after a 11-year hiatus, resurveyed in 2012 and 2013. In 2000, the cross section was extended across the valley to station 334.7 at a fence line.

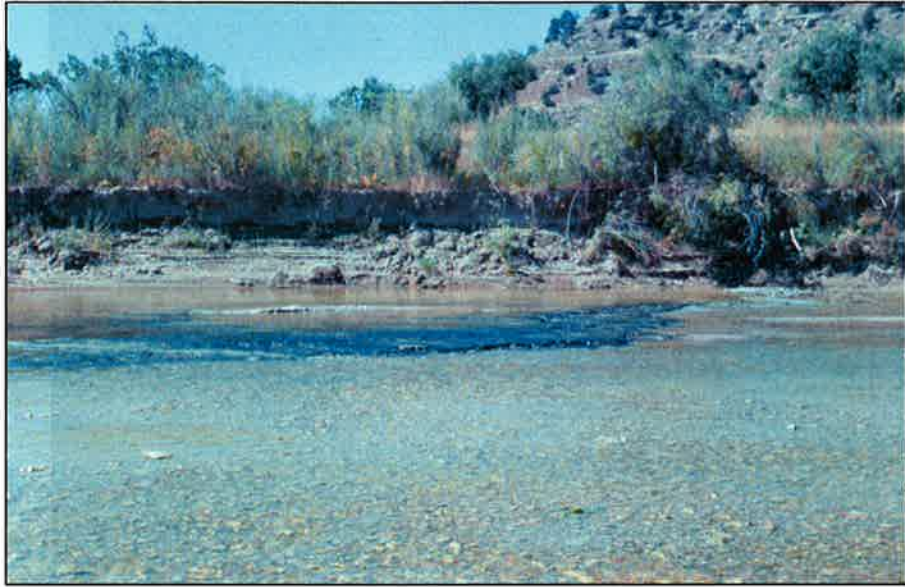
PR130. **Top.** 9 September 1975. View is of the left bank about 25 m upriver from section PR130. River is flowing from left to right, and coal outcrop is visible along the left bank. **Bottom.** 21 July 1977. View is upriver and E. Meade (~1.6 m tall) is standing on the coal outcrop. About 25 m upriver from section PR130. Red line is approximate location of the cross section.

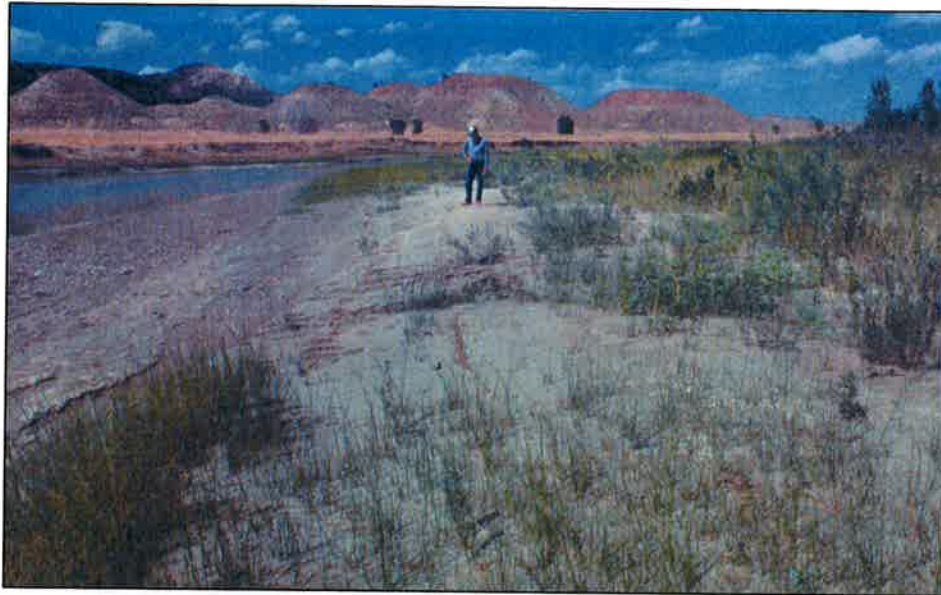
PR130. **Top.** 18 August 1986. View is downriver along the right bank, showing the new sand (0.1-0.3 m) on the point bar. J. Moody (~1.9 m tall) is standing at station 72. **Bottom.** 19 September 1988. View is upriver. J. Moody and tripod with level are just upriver from section PR130.

The flood in 1978 eroded 2.4 m from the left bank and left some lee-dune-type deposits of new sand (Moody and Meade, 2008) on the right-bank flood plain (Meade and Moody, 2013, *their* Figure 6). No changes were measured for the next five years. A levee began to develop in the cross sectional profile along the right bank in 1982 and was the first evidence of the beginnings of a new inset floodplain similar to those described by Moody et al. (1999). This floodplain was built in three stages in 1982-1984, 1990-94 and 1995. Initially, the floodplain was narrow and only about 10 m wide in 1984, but additional sediment deposited in 1987 widened the floodplain to about 20 m and added ~0.30 m of height. In 1990, a little bench (~4m wide) was added on the riverward side of the nascent floodplain, and then in succeeding years (1991 and 1993) additional sediment was added on top of this bench until it was higher than the original floodplain deposited in 1982-1984. This new inset floodplain was about 28 m wide in 1994. During the last stage, a large and long snowmelt flood lasting from May through July 1995 deposited a wedge of sediment, which was about 0.5 m thick nearest to the river and tapered to about 0.05 m in the floodplain trough farthest from the river.

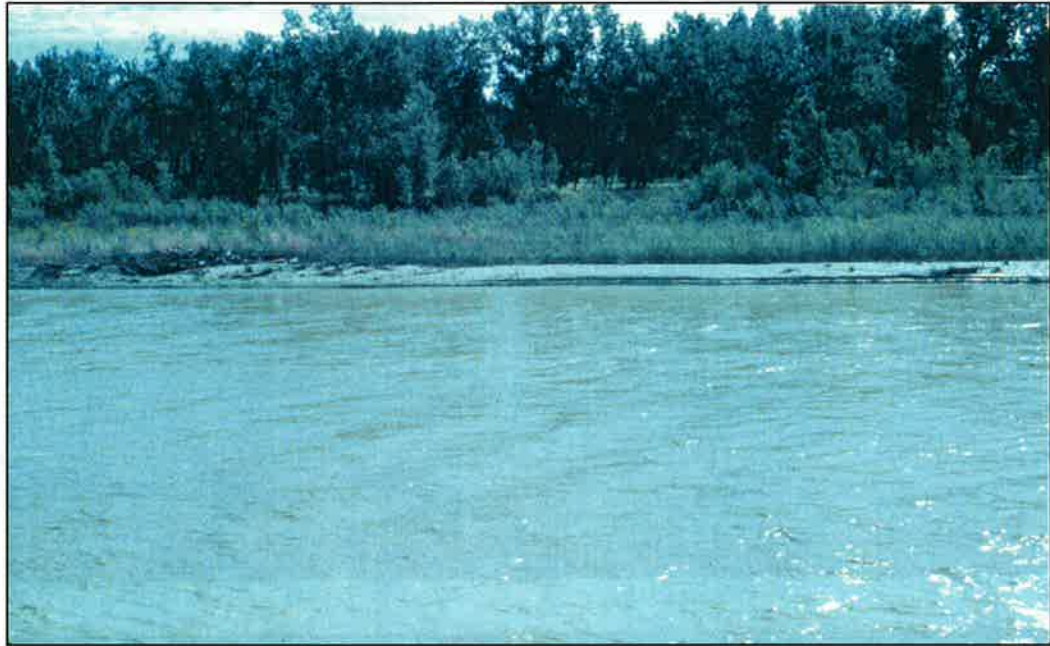
PR130. **Top.** 11 June 1993. View shows a new sand bench deposit on the right bank. **Bottom.** 24 September 1995. View is downriver, showing new sand deposited behind the berm crest and about 0.5 m thick on point bar.

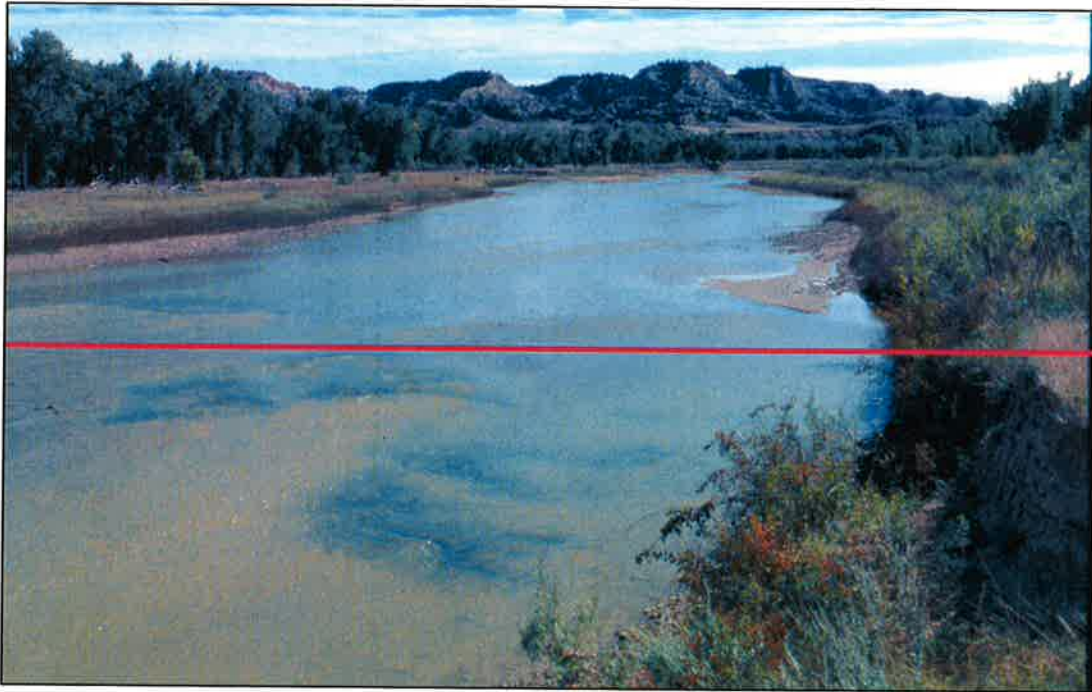
PR130. **Top.** 19 September 1997. View upriver of section, showing coal outcrop in river bed. **Bottom.** 20 October 2012. View is downriver showing coal outcrop along the left bank just upriver from cross section PR130. Red lines are approximate locations of the cross section.

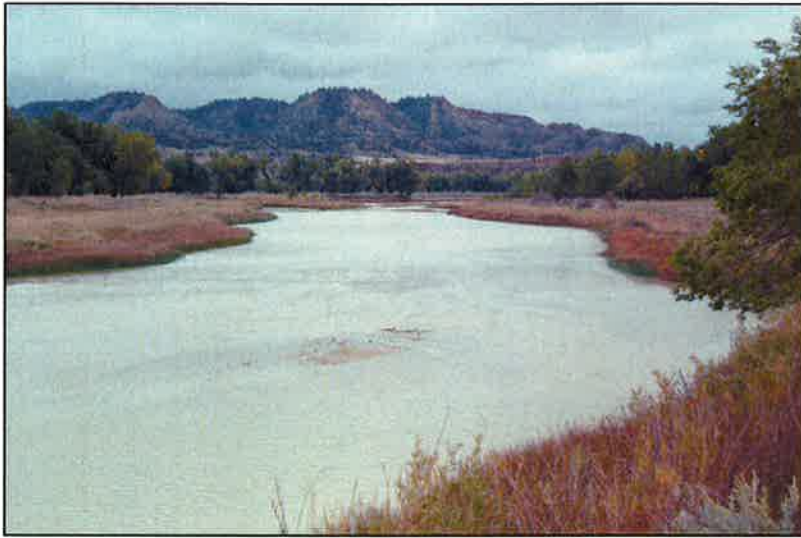
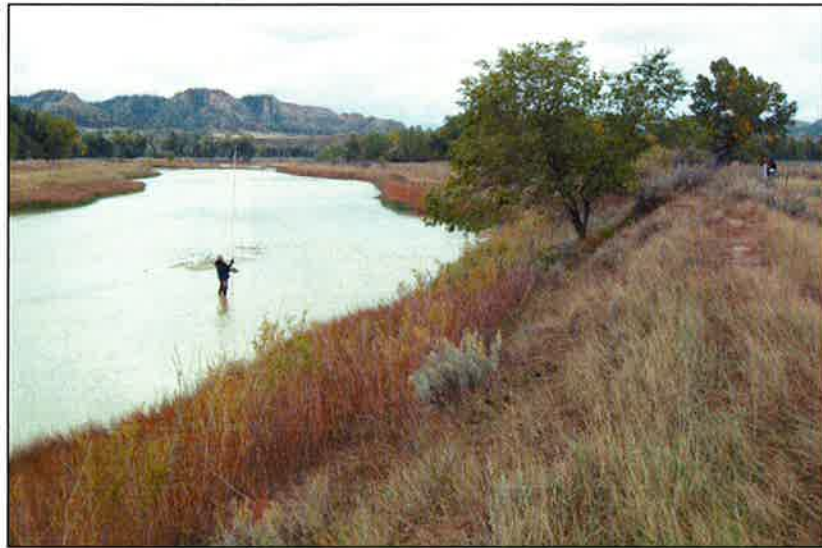
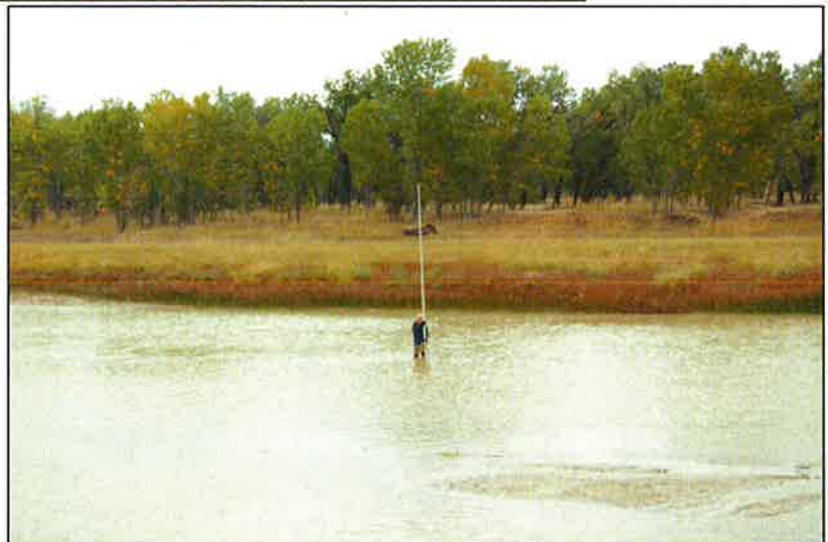
PR130. **Top.** 27 September 2013. View upriver. **Middle.** J. Moody (~1.9 m tall) is on section, and D. Martin is standing at the tripod on the left bank. **Bottom.** View of right bank with grass on point bar. J Moody is at station 45.
